イタルダインフォメーション ITARDA INFORMATION 交通事故分析レポート No.136

Special Accidents from collisions between four-wheel vehicles turning right and four-wheel vehicles going straight

~ Preventing a delay in noticing other vehicles is effective for avoiding accidents ~

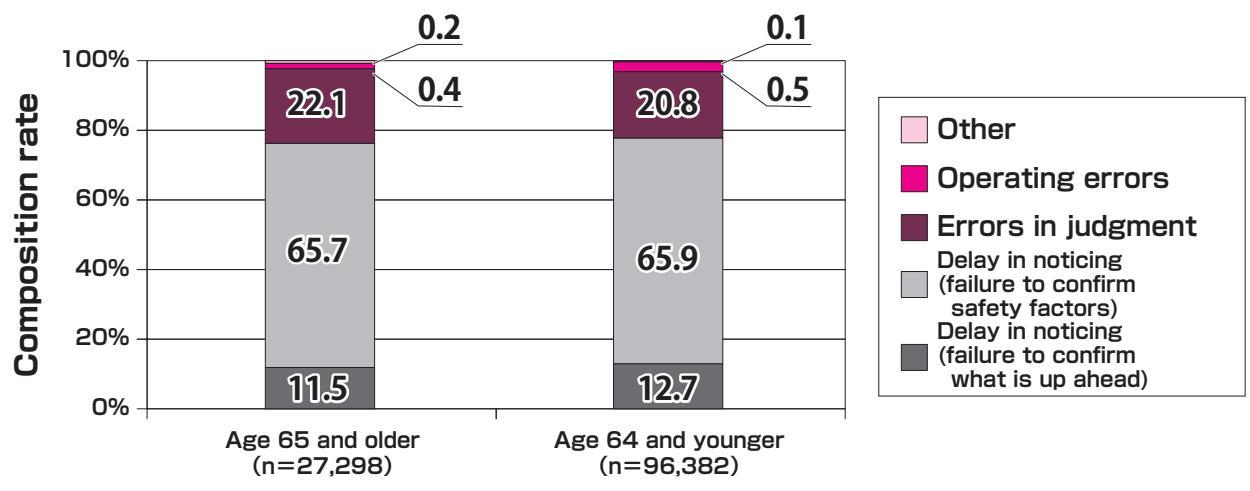
In addition, when viewed in terms of trends by age group, the human factors by age group for those age 65 and older (elderly people) and those age 64 and younger exhibit largely identical composition rates (Fig. 1). This reveals that the causal factors behind the occurrence of accidents between a vehicle turning right and a vehicle going straight are commonly shared irrespective of the age group.

Fig. 1. Human factors on the part of the primary party by age group for collision accidents between a four-wheel vehicle turning right and a four-wheel vehicle going straight

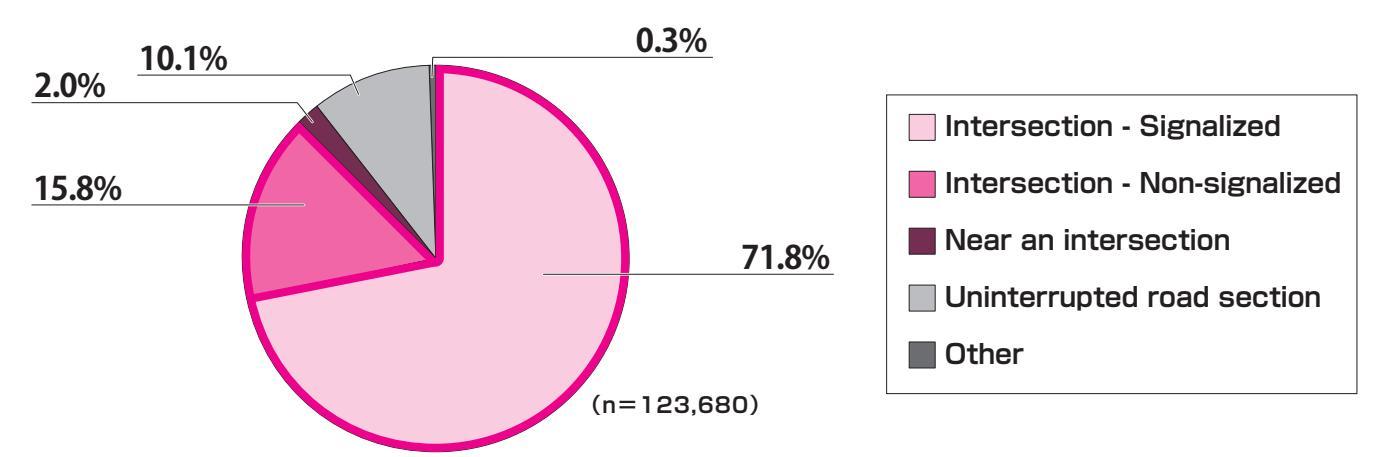
Next, Fig. 2 shows collision accidents between a four-wheel vehicle turning right and a four-wheel vehicle going straight by the locations where they occurred. Intersections accounted for just under 90% of the total, with more than 70% of these occurring at signalized intersections.

Fig. 2. Locations where collision accidents between four-wheel vehicles turning right and four-wheel vehicles going straight occurred [macrodata (2009 - 2018)]

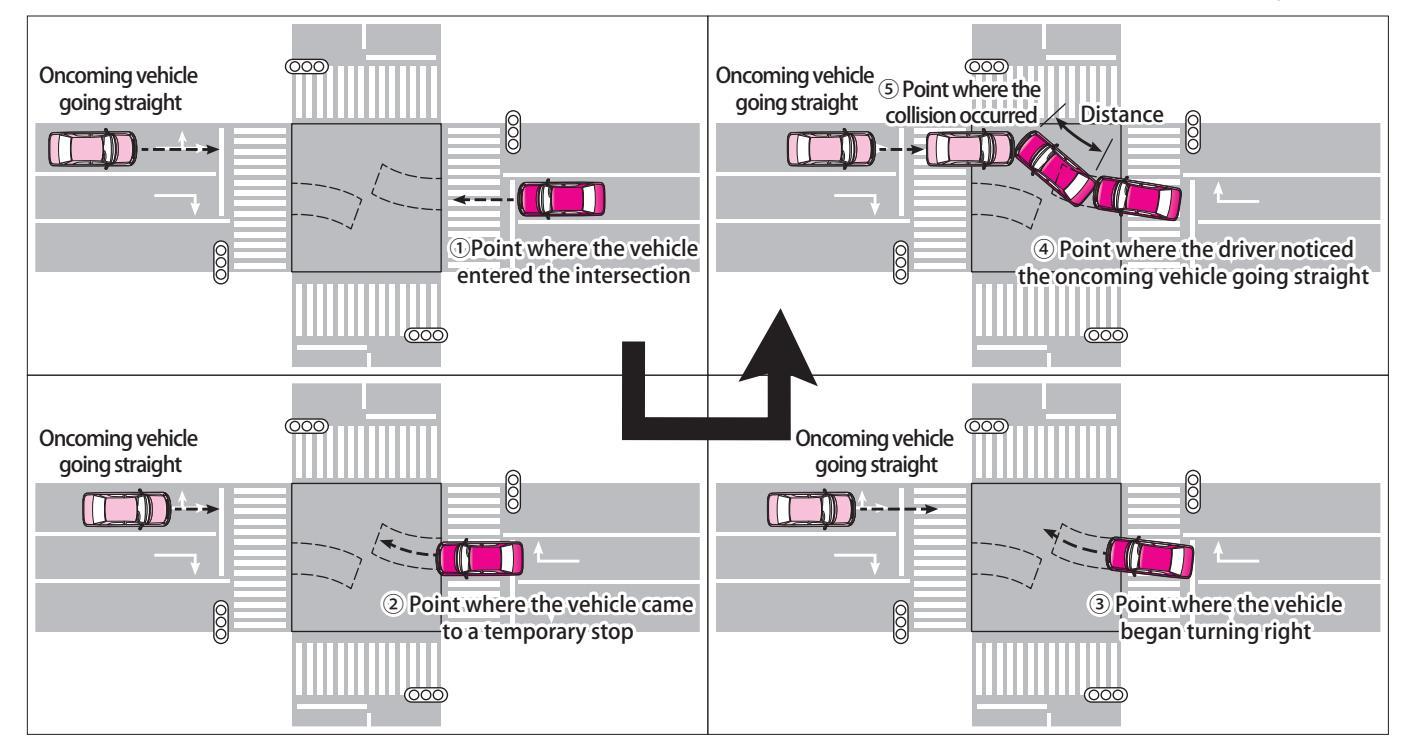
Fig. 3. Points of travel from when the vehicle turning right enters the intersection until the collision occurs (conceptual diagram)

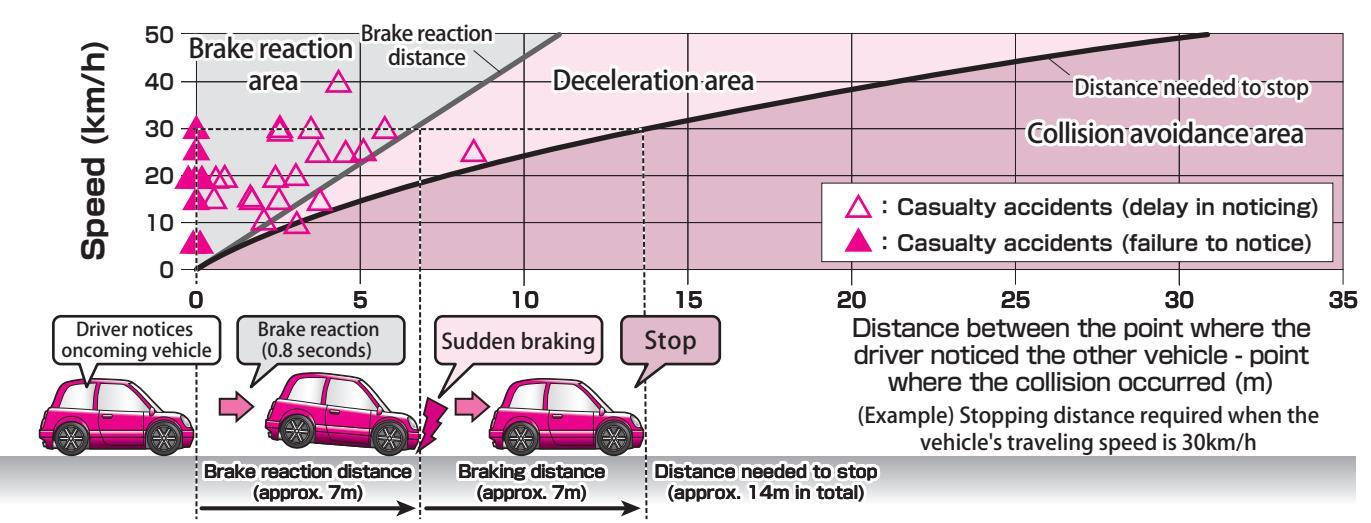
In the microdata from 2009 - 2018, there were 46 accidents between a vehicle turning right and a vehicle going straight that were deemed to have been caused by a delay in noticing the oncoming vehicle going straight on the part of the driver of the vehicle turning right. Of these, there were 28 accidents where the traveling speed at the point where the driver noticed the oncoming vehicle going straight (④) and the distance between this point and the point where the collision occurred (④→⑤) could be ascertained. For these accidents, the vehicle's speed and these distances were plotted on Fig. 4. In addition, a solid black line was used to indicate the distance needed for a four-wheel vehicle to come to a stop based on calculations on this same graph. The distance needed to come to a stop was found by totaling the brake reaction distance calculated based on a reaction time'⁵ of 0.8 seconds (the solid gray line) and the braking distance calculated based on a deceleration from braking of 0.5G.

Fig. 4. Actual distance between the point where the driver noticed the oncoming vehicle going straight and the point where the collision occurred and the distance needed to stop based on calculations [microdata on 28 accidents (2009 - 2018)] Fig. 4 reveals that in more than 90% of the cases (27 of the 28 accidents), the distance between the point where the driver noticed the oncoming vehicle going straight and the point where the collision occurred was shorter than the distance needed to stop. This indicates that it was theoretically impossible to avoid the collision at the point in time where the driver noticed the oncoming vehicle going straight. In addition, just shy of 90% of the accidents (25 of the 28 accidents) were distributed within the brake reaction area. This reveals that these collisions occurred when the driver failed to notice the oncoming vehicle going straight (distance between the point the driver noticed the other vehicle and the point where the collision occurred = 0m) or when they noticed said vehicle right before the collision and just after they began to decelerate. So then why were they unable to notice the oncoming vehicle going straight until right before the collision was imminent?

For the 28 accidents from Fig. 4, back-of-the-envelope estimates of the number of accidents that could have potentially been stopped before the collision^{•6} were made for different cases, with the results shown in Fig. 8 and Fig. 9, respectively. These cases are: 1) An alarm notifies the driver of the oncoming vehicle going straight at the point where the vehicle began turning right (Fig. 3 (3)), and the driver applies the brakes (or damage mitigation brakes activate). 2) An advance notification^{•7} from signals between vehicles or between the road and the vehicle notifies the driver at the stage right before they begin making the right turn (point where the vehicle entered the intersection (Fig. 3 (1)) or the point where the vehicle came to a temporary stop (Fig. 3 (2))) and the driver applies the brakes. The reaction time (0.8 seconds), deceleration (0.5G), and traveling speed when the driver noticed the oncoming vehicle going straight were assumed to be the same as in Fig. 4.

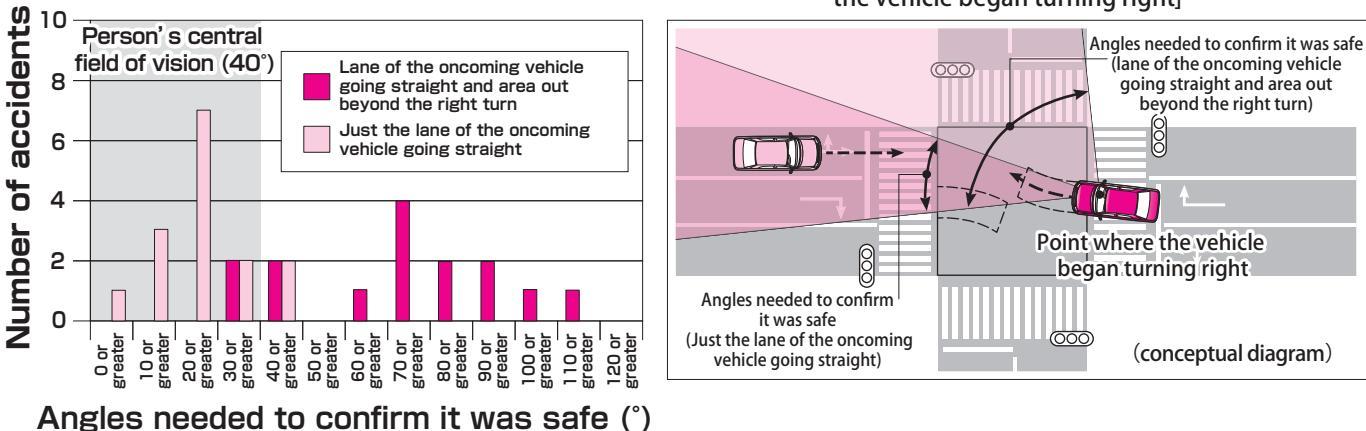
Fig. 5 shows the results of arranging the angles needed to confirm it was safe in cases where the driver is only looking at the lane of oncoming vehicles going straight from the point where the vehicle began turning right and cases where they were looking at this lane and the area out beyond the right turn for the locations where the 15 accidents subject to review occurred. The angles needed to confirm it was safe were determined based on a combination of the width of the crossing road, the crossing angle, and the point where the vehicle began turning right.

Fig. 5. Angles needed to confirm it was safe from the point where the vehicle began turning right in cases where the driver was preoccupied by the area out beyond the right turn

A person's central field of vision is said to be about 40° (20° in either direction). In cases where a driver is only looking at the lane of oncoming vehicles going straight, based on Fig. 5 we can see that they can only perceive things visually in roughly one direction, yet when they view both the aforementioned lane and the area out beyond the right turn this encompasses every angle, representing an area that is two to three times greater than their central field of vision. In other words, compared to a situation in which they are only looking at the lane of oncoming vehicles going straight, such as when they are going straight ahead, this increases the complexity in the sense that now they have to check to confirm that it is safe two to three times as frequently, which presumably could potentially lead to a failure to confirm safety factors with collisions while turning right.

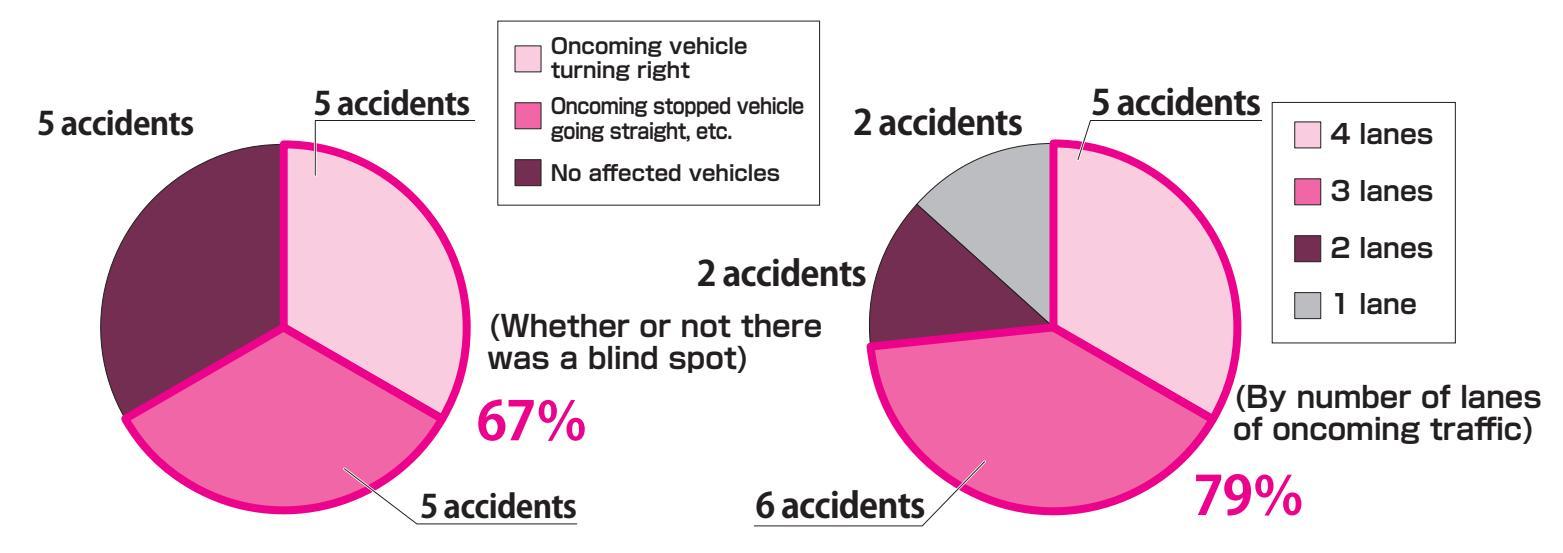
Fig. 6 shows a breakdown of the 15 accidents subject to review in terms of the share of accidents that occurred by whether or not there was a blind spot and the number of lanes of oncoming traffic (including right-turn lanes). Accidents that were impacted by oncoming vehicles turning right, oncoming vehicles going straight that were stopped in traffic congestion, and so forth accounted for two-thirds of all of these cases. In addition, cases where there were a larger number of lanes of oncoming traffic at three or four accounted for just shy of 80% of the total nursing of cases.

Fig. 6. Share of accidents between a vehicle turning right and a vehicle going straight by whether or not there was a blind spot / number of lanes in cases where the driver did not realize an oncoming vehicle going straight was approaching [microdata on 15 accidents (2009 - 2018)]

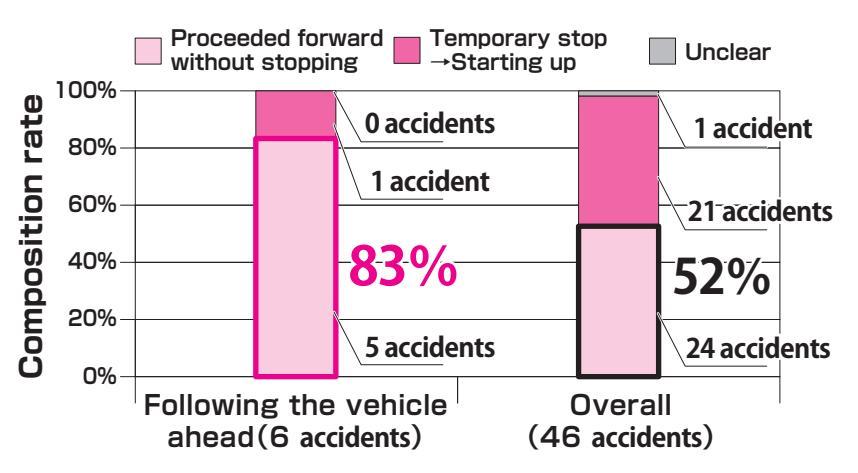
Fig. 7 shows a breakdown of driving behavior at intersections. The share of cases where the driver proceeded ahead without stopping accounted for more than 80% (five out of six accidents) of cases where the driver followed the vehicle ahead of them, which represents a significant difference in that this is just over 50% for all 46 accidents on the whole (24 out of 46 accidents). It is believed that a sentiment of wanting to rush through the right turn without attempting to act prudently, such as by coming to a temporary stop, could potentially give rise to mistaken impressions like this on the part of drivers.

Fig. 7. Comparison of driving behavior at an intersection

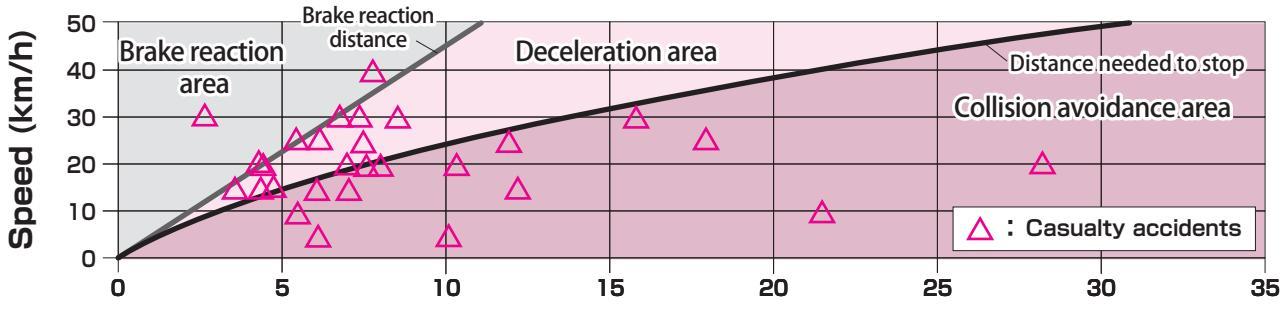
Distance from the point where the vehicle began turning right to right before the collision (m) Fig. 8. Whether or not a collision occurred in cases where the driver noticed the other vehicle and braked at the point where the vehicle began turning right [microdata on 28 accidents (2009 - 2018)]

Based on the results of these back-of-the-envelope estimates, in the case of 1) collisions could have been avoided 50% of the time (14 out of 28 accidents) (Fig. 8). In the case of 2), collisions could have been avoided in more than 70% of the time (20 out of 28 accidents) (Fig. 9). As the above indicates, combining improvements in driver awareness and behavior with assistance from the road environment and vehicle technology could presumably give rise to greater effects in terms of reducing accidents.

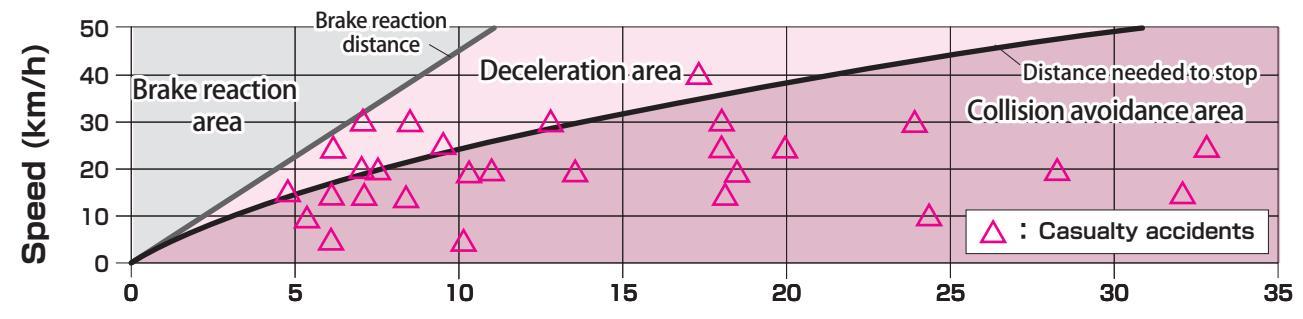
Distance from the point where the vehicle entered the intersection / point where the vehicle came to a temporary stop to right before the collision (m)

Fig. 9. Whether or not a collision occurred in cases where the driver noticed the other vehicle and braked at the stage prior to starting to turn right [microdata on 28 accidents (2009 - 2018)]
