ITARDA INFORMATION

No.128

Accidents when four-wheel vehicles are reversing

~ Drivers must thoroughly check behind them, especially in parking lots! ~

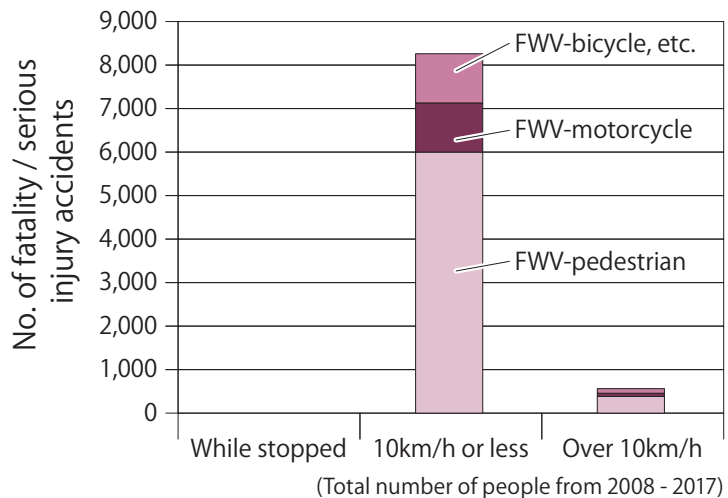
Fig. 3 shows the danger perception speed (speed the driver was traveling when they became aware of the danger) of the reversing vehicle involved in fatality / serious injury accidents. Most reversing accidents occur at low speeds of 10km/h or less, with this indicating that few such accidents occur in the speed range over 10km/h.

Fig. 3. Danger perception speed of the primary party for reversing accidents involving fatalities / serious injuries

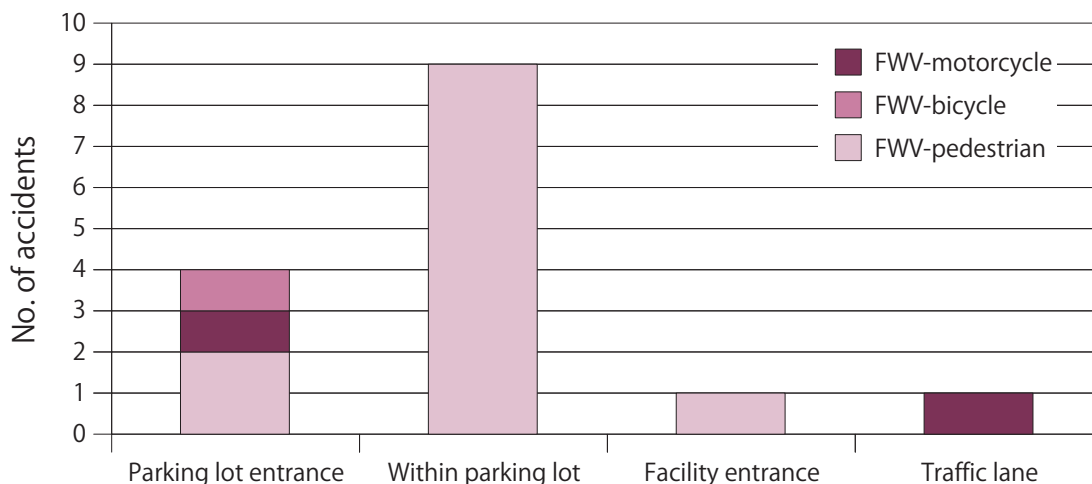
The locations where the 15 accidents from the micro-data occurred are shown in Fig. 8. From the results of this, we can affirm that many of the pedestrians were involved in collisions with reversing vehicles within parking lot-related facilities. Therefore, this is largely consistent with the result from Figs. 4-1 and 4-2 that many of the accidents between four-wheel vehicles and pedestrians occur in general traffic areas.

Fig. 8. Locations where reversing accidents involving casualties occurred found in the micro-data
